March 29, 2019

Re: Subsurface Investigation
Storm Water Ponds and Dredge Material Containment Area
Bucksport Marina
Bucksport, South Carolina
GeoTechnologies Project No. 1-18-0747-EA2

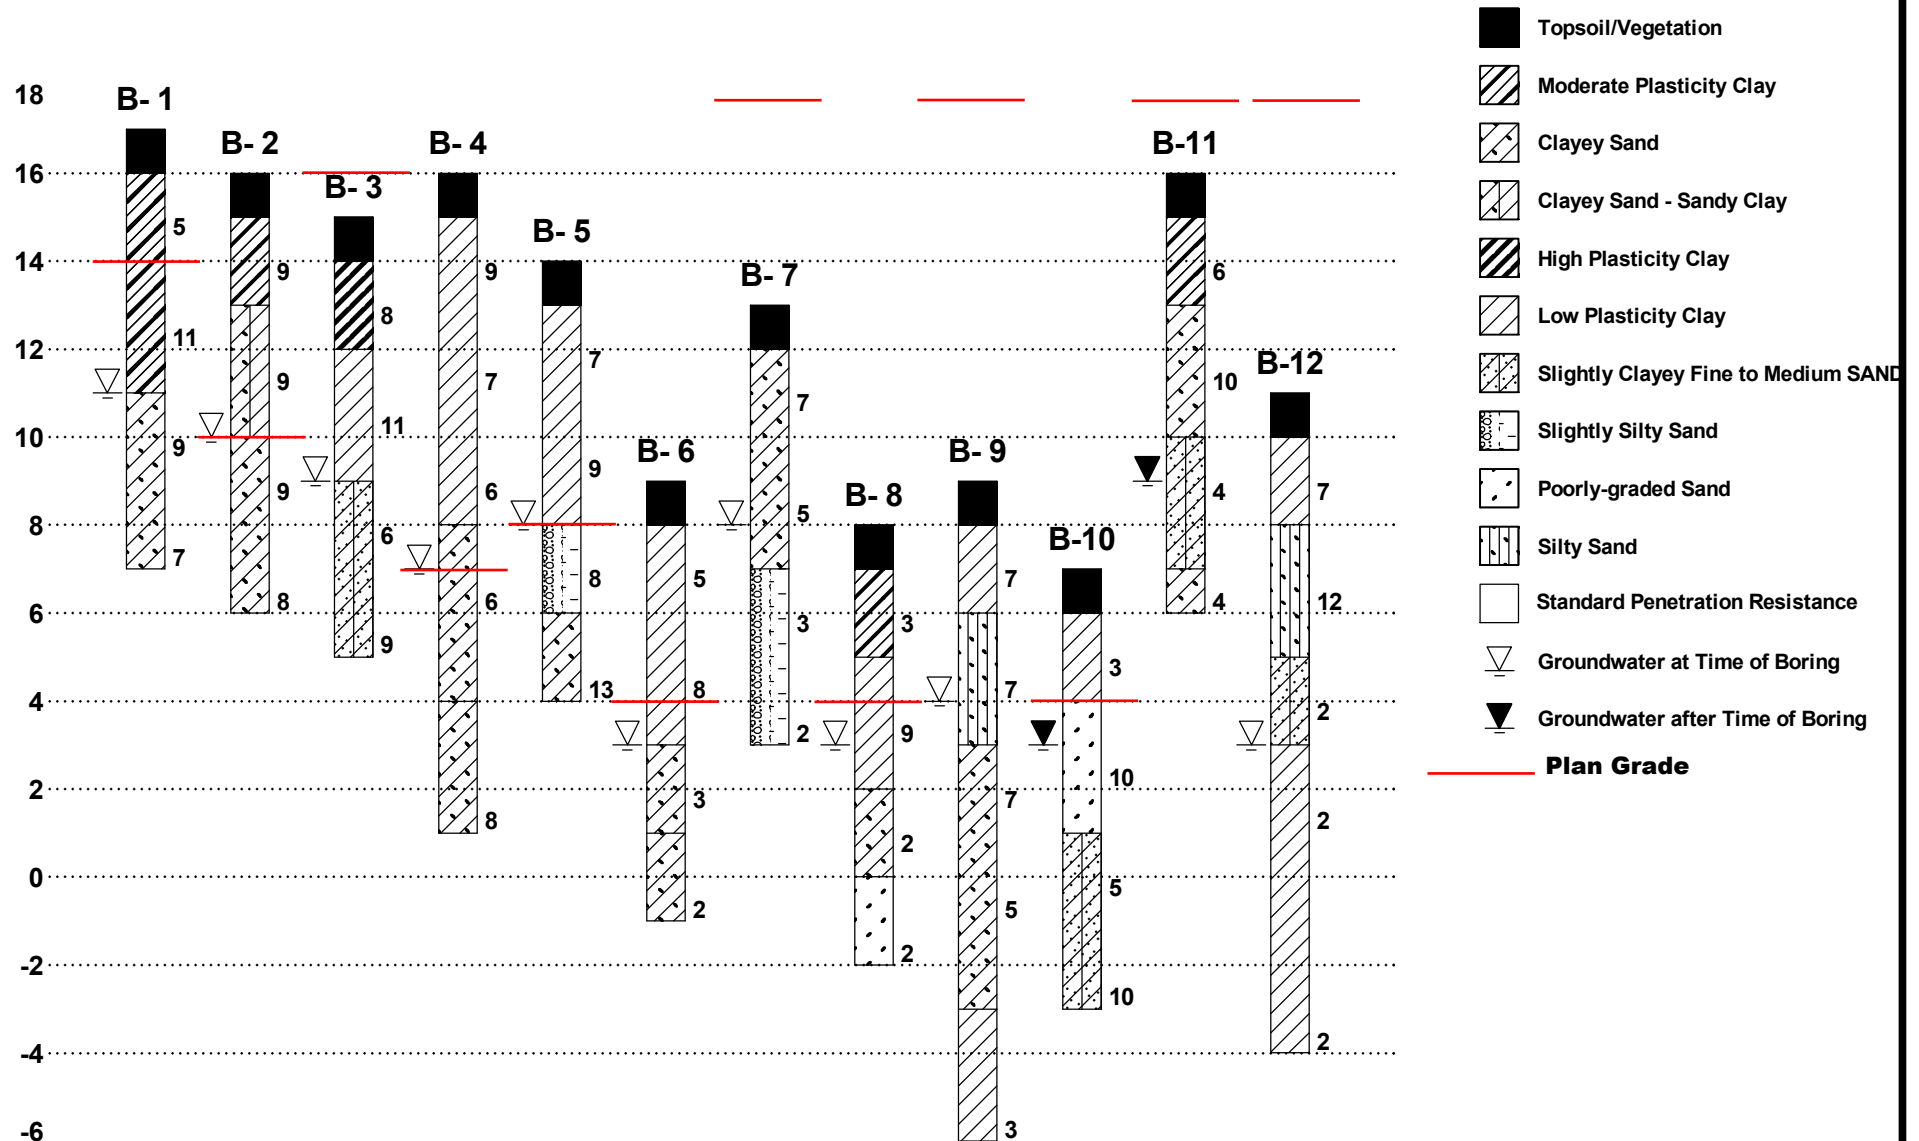
FIGURE No:2A

Generalized subsurface profile prepared from the test boring data are attached to this report as Figures 2A and 2B to graphically illustrate subsurface conditions encountered at this site. More detailed descriptions of the conditions encountered at the individual test boring locations are then presented on the test boring records in Appendix A.

The site is overlain by a veneer of topsoil/soil in most areas. These materials are initially underlain by low to high plasticity clays and silty or clayey sands with penetration resistances of no less than 3 blows per foot (bpf). With depth, the borings encountered low plasticity clays, and silty, clayey, or clean sands with penetration resistances of at least 2 bpf. The borings were terminated at 10 to 20 feet.

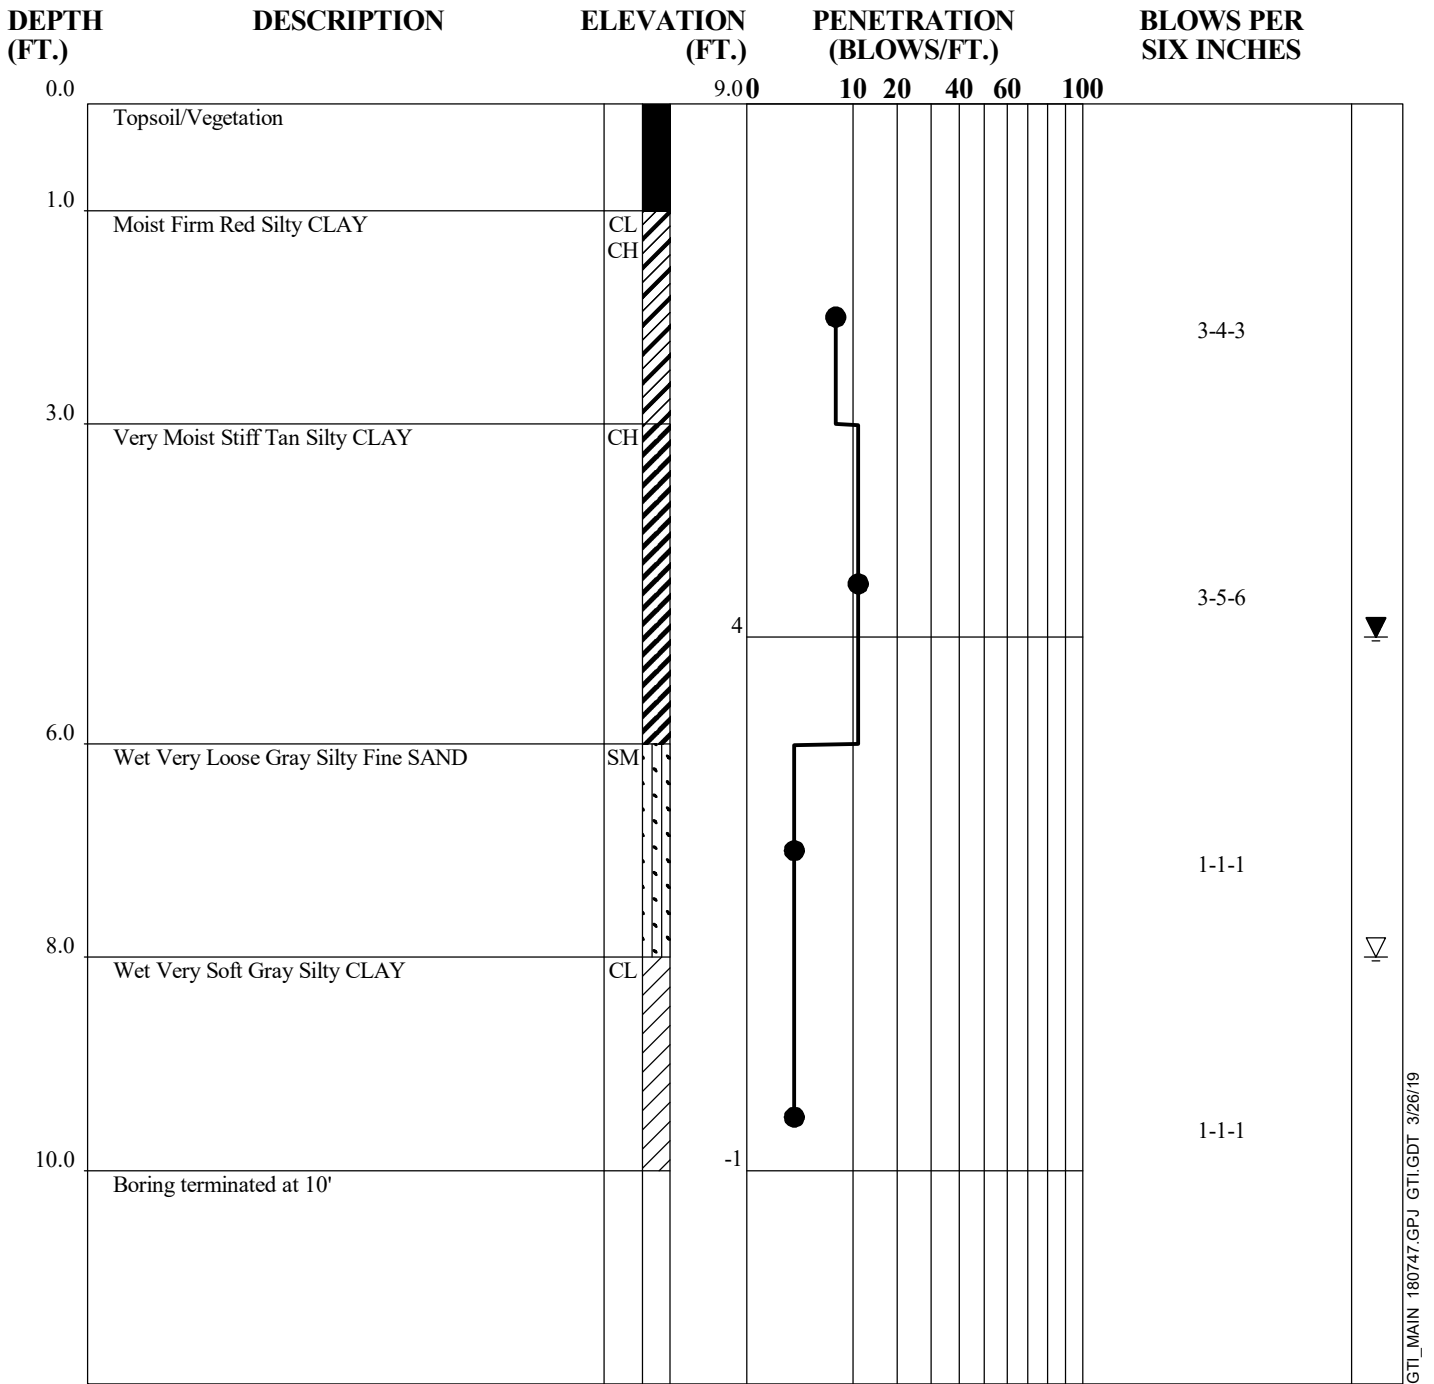
JOB NUMBER 1-18-0747-EA
BORING NUMBER B-12
DATE 3-18-19

The deepest fills are located on the west side of the dredge spoils containment area. Our analysis of a 10 foot well compacted fill slope over the boring B-12 profile indicates a safety factor in excess of 1.5 which is acceptable. Our analysis assumed that dredge spoils could be placed to crest height of the berm, and that a phreatic surface could develop through the berm, both of which appear conservative. It was also conservatively assumed that the dredge material has no shear strength.

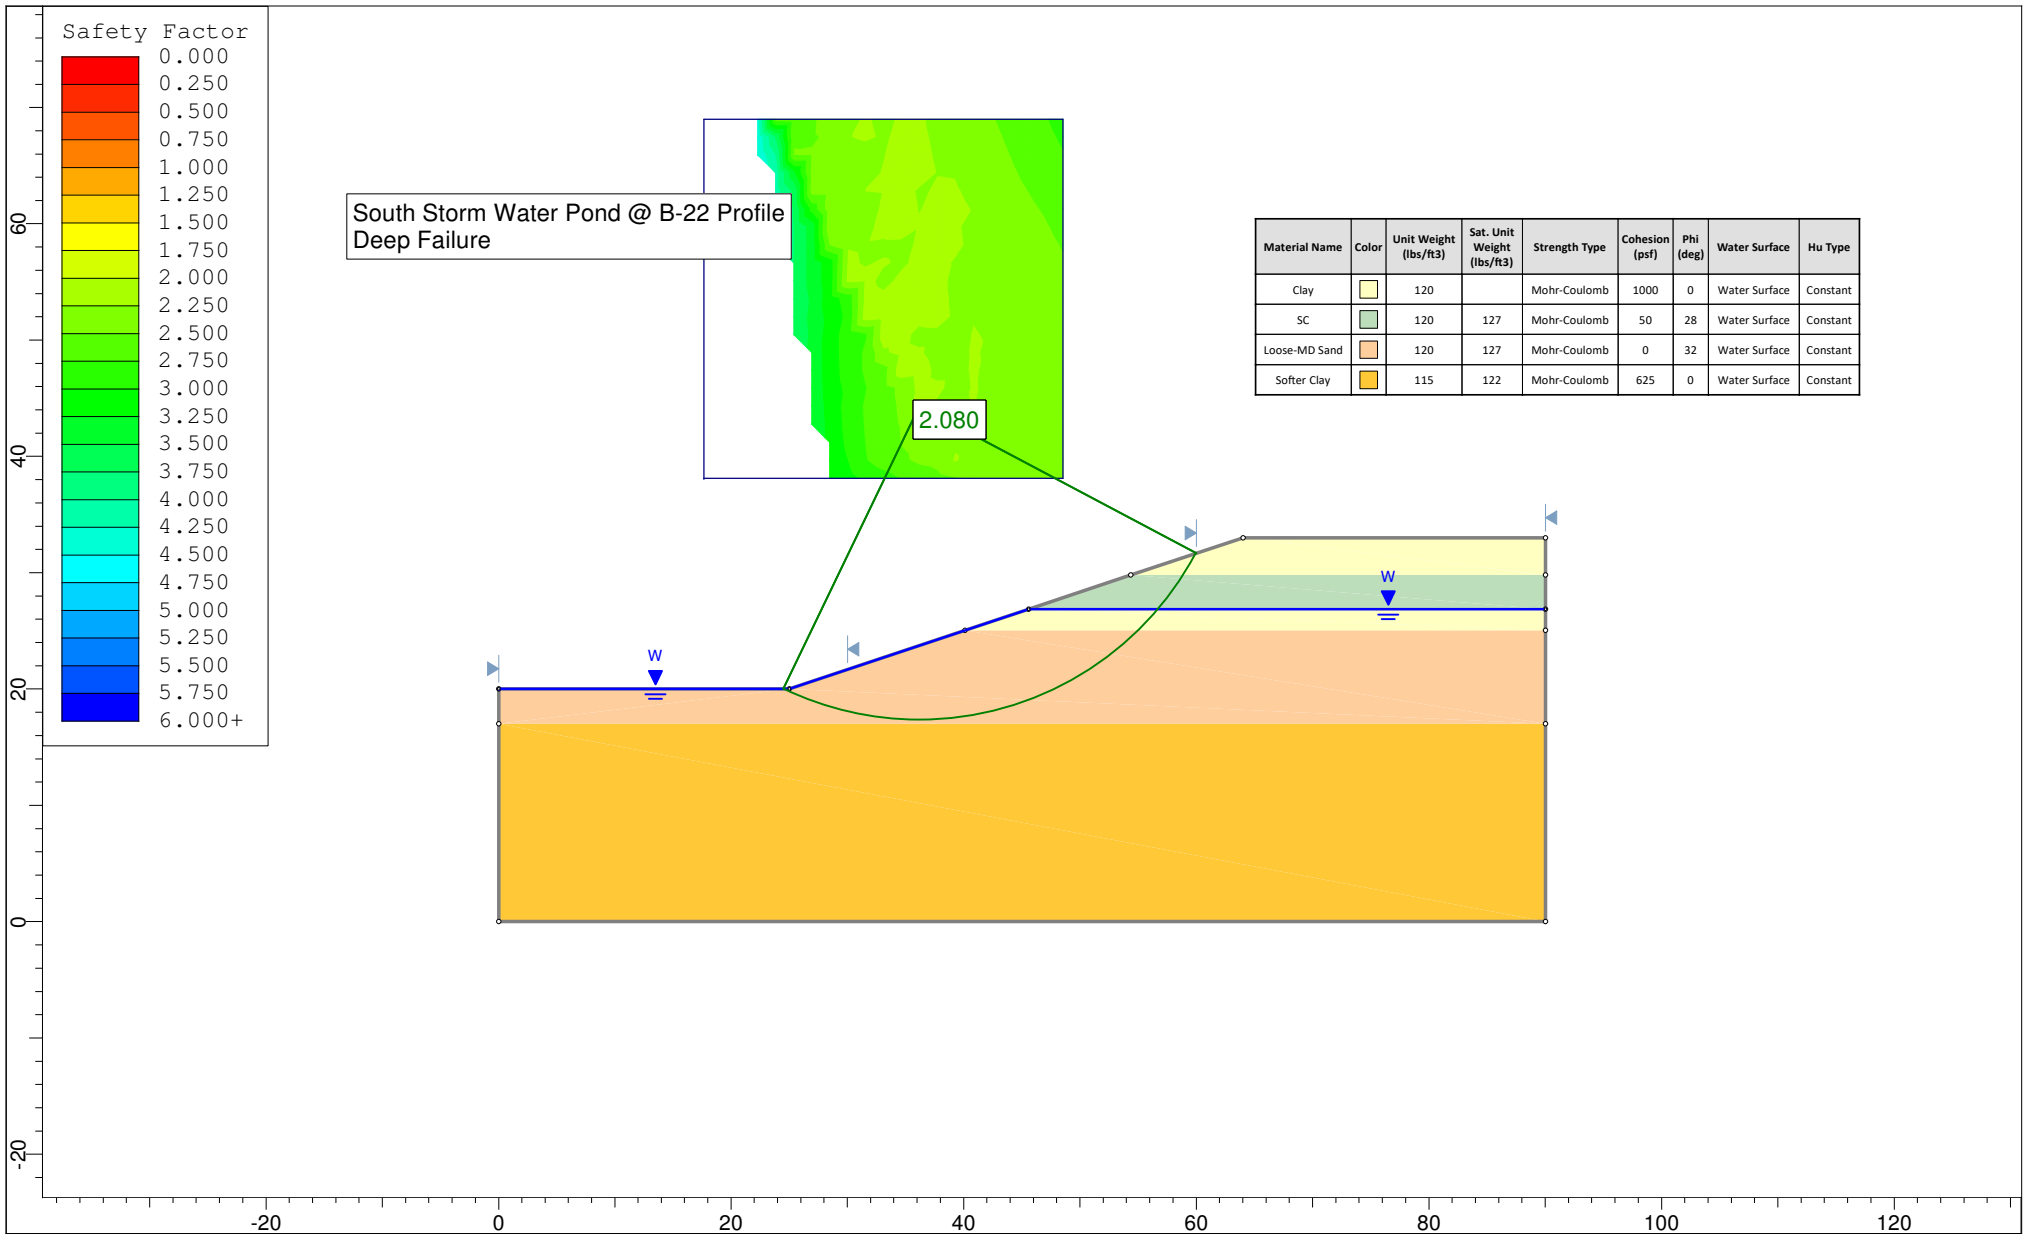
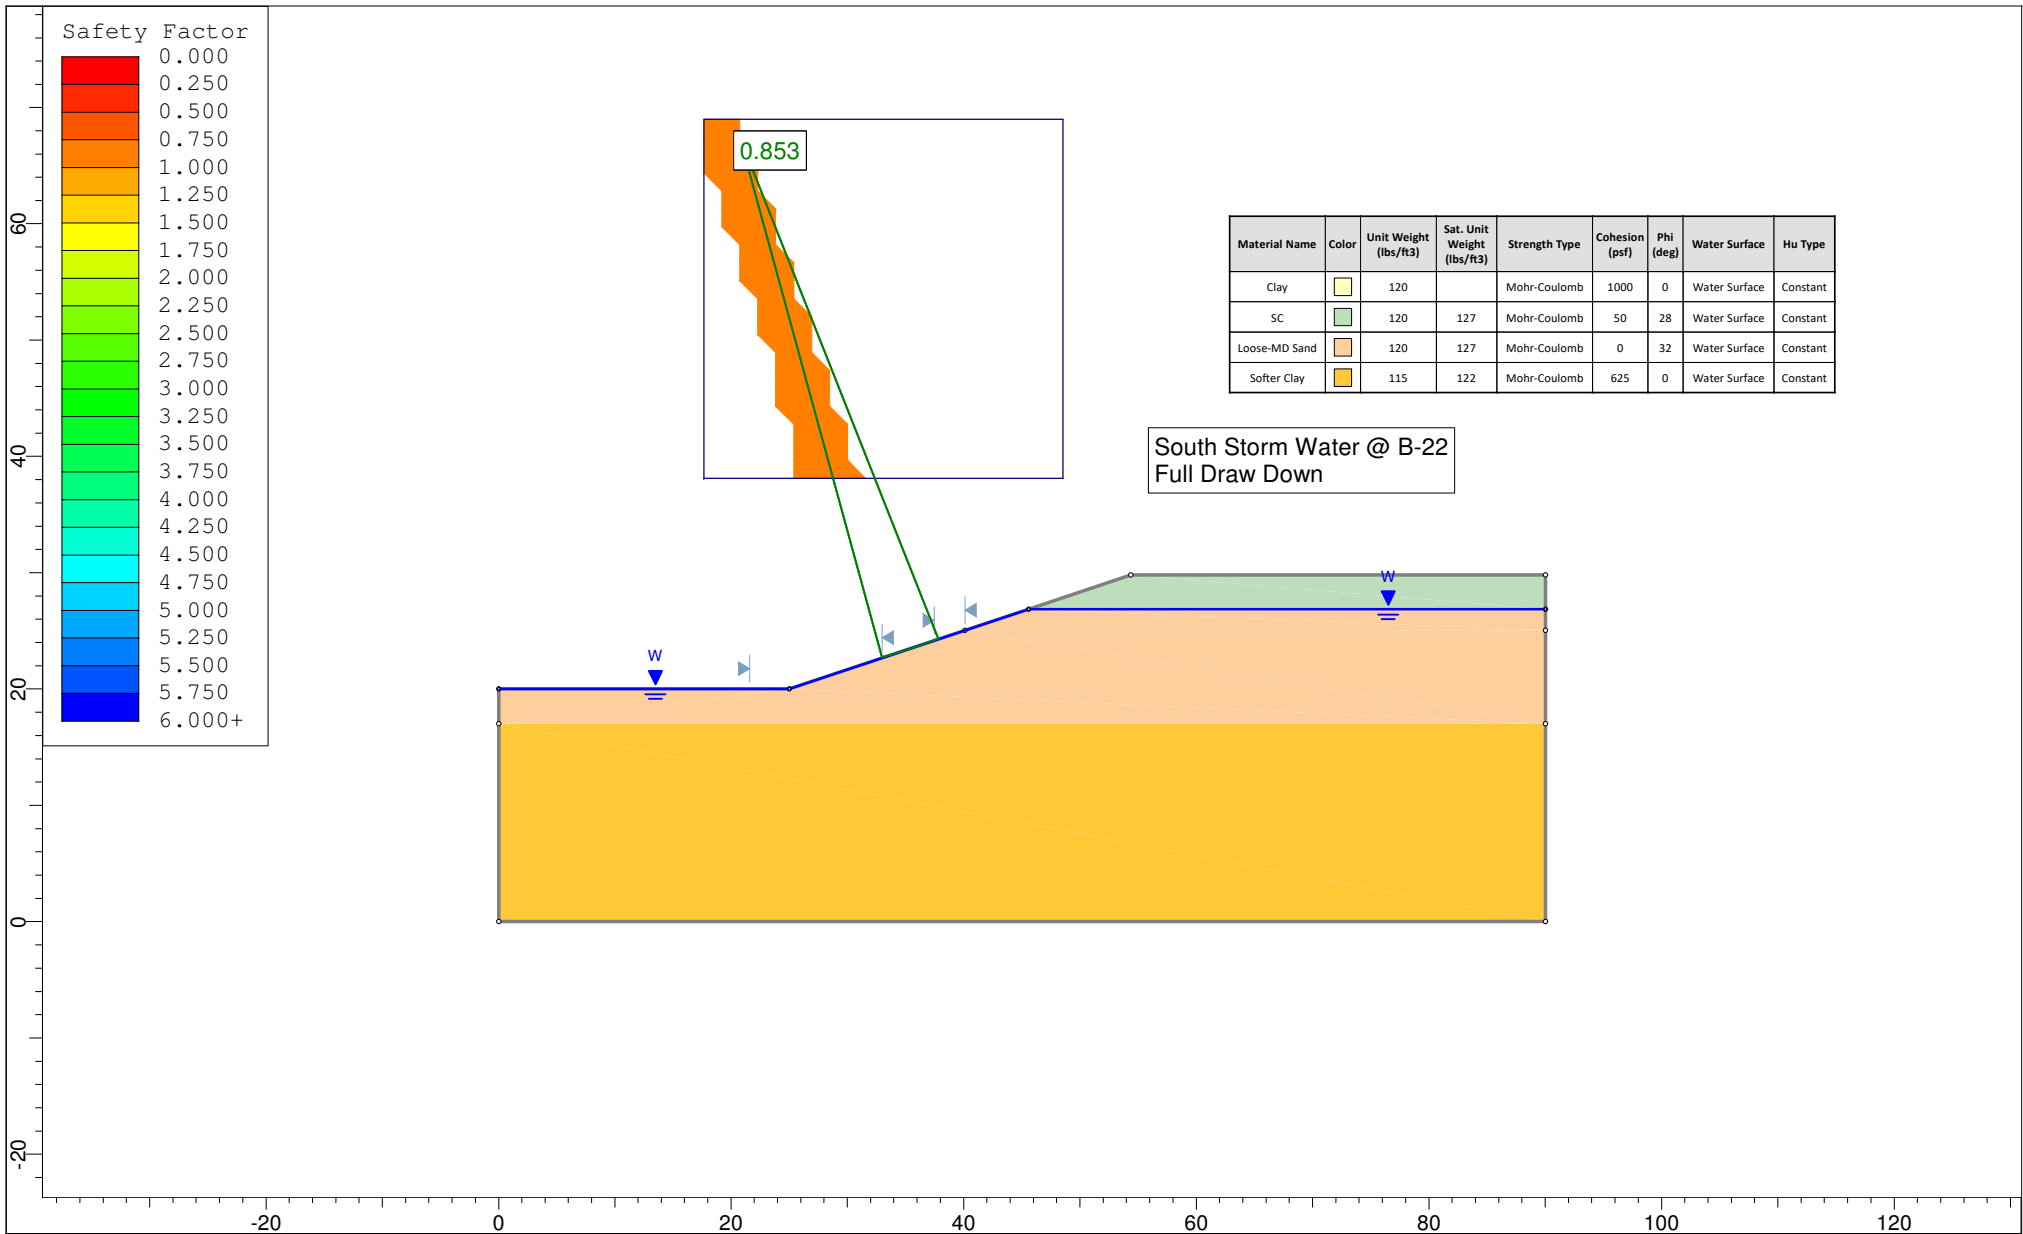
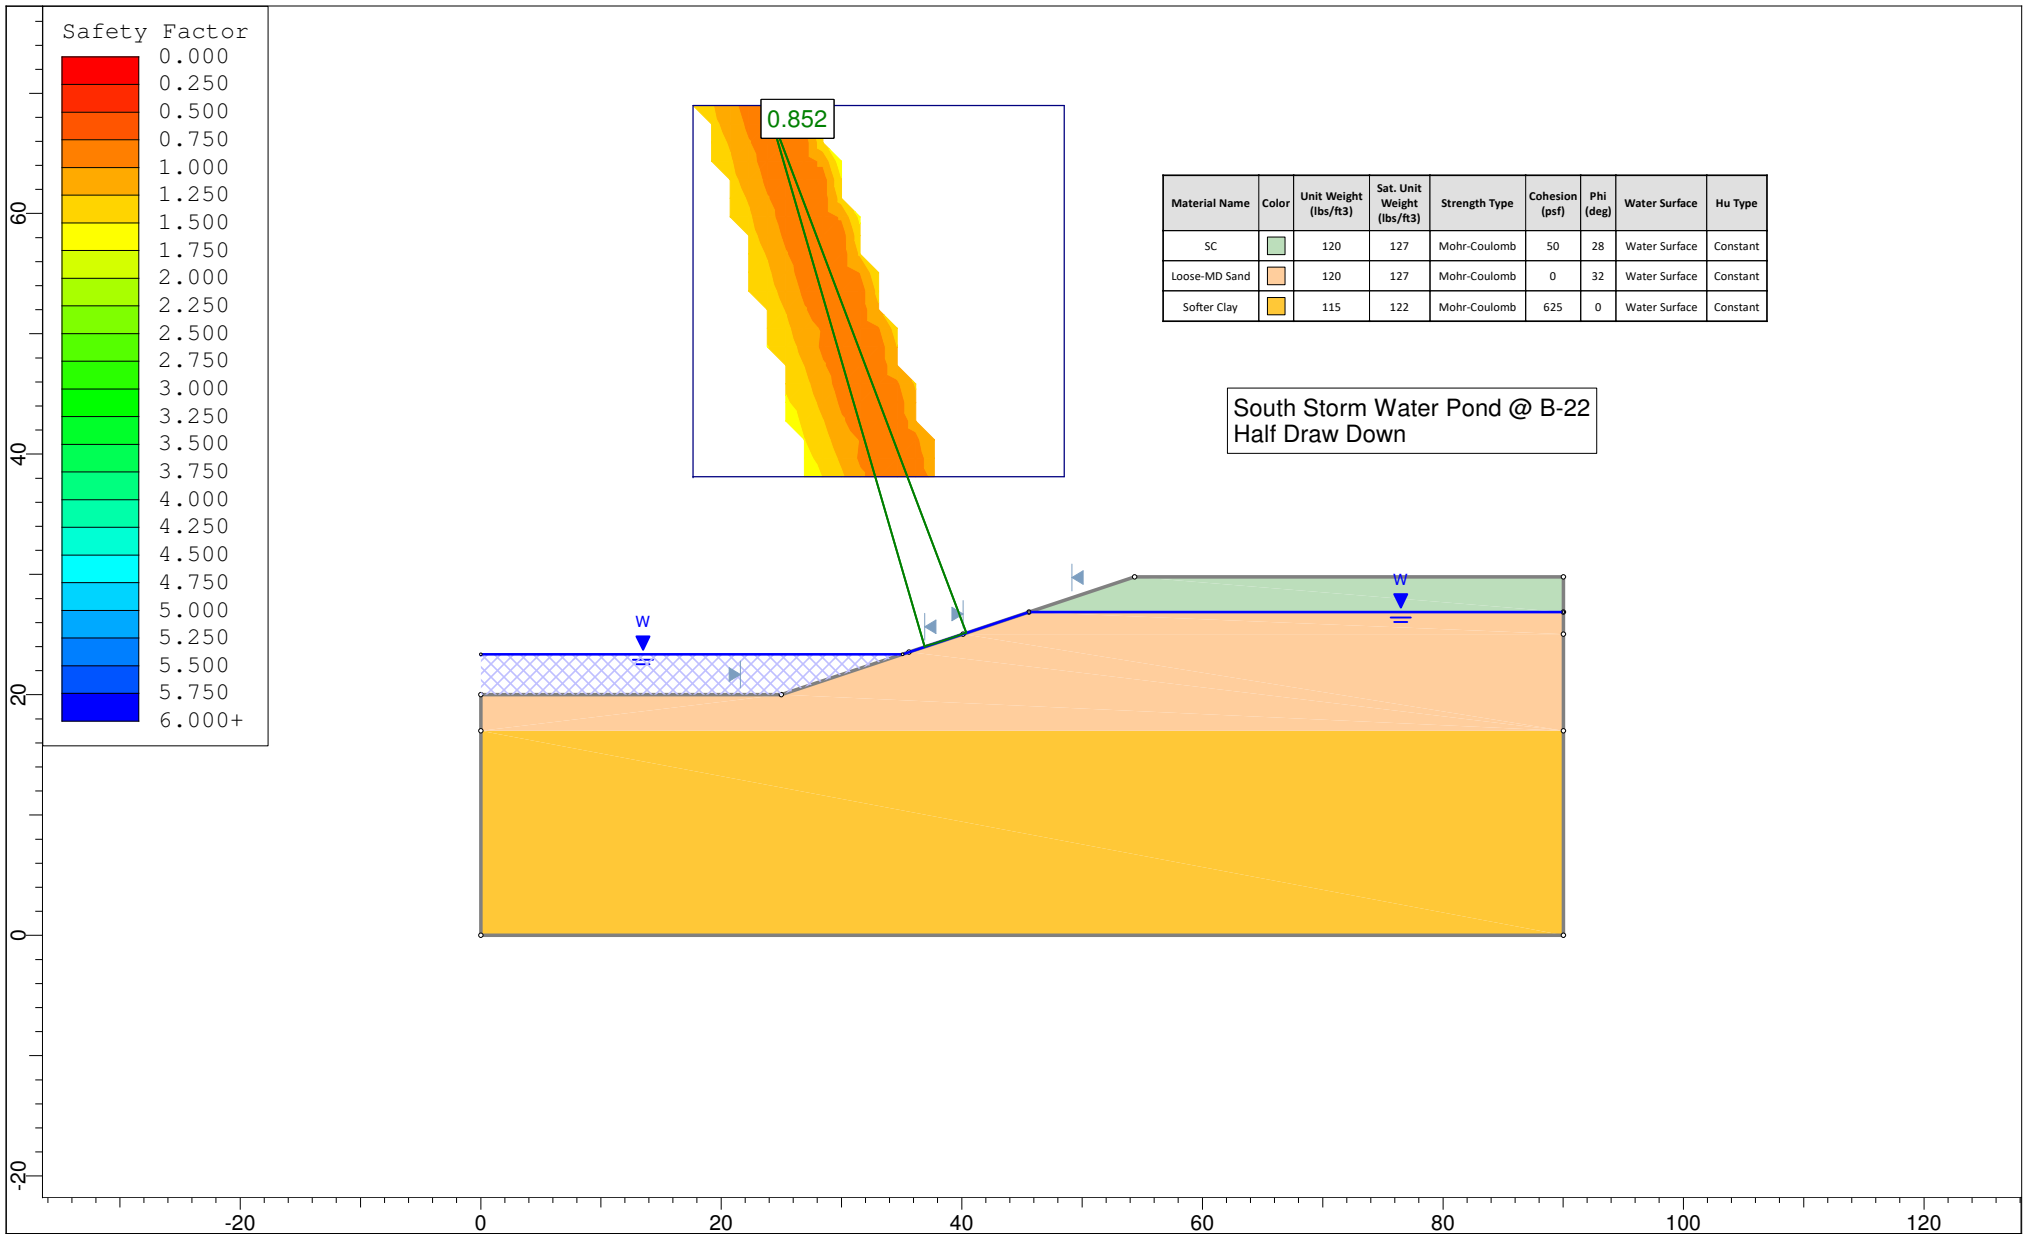
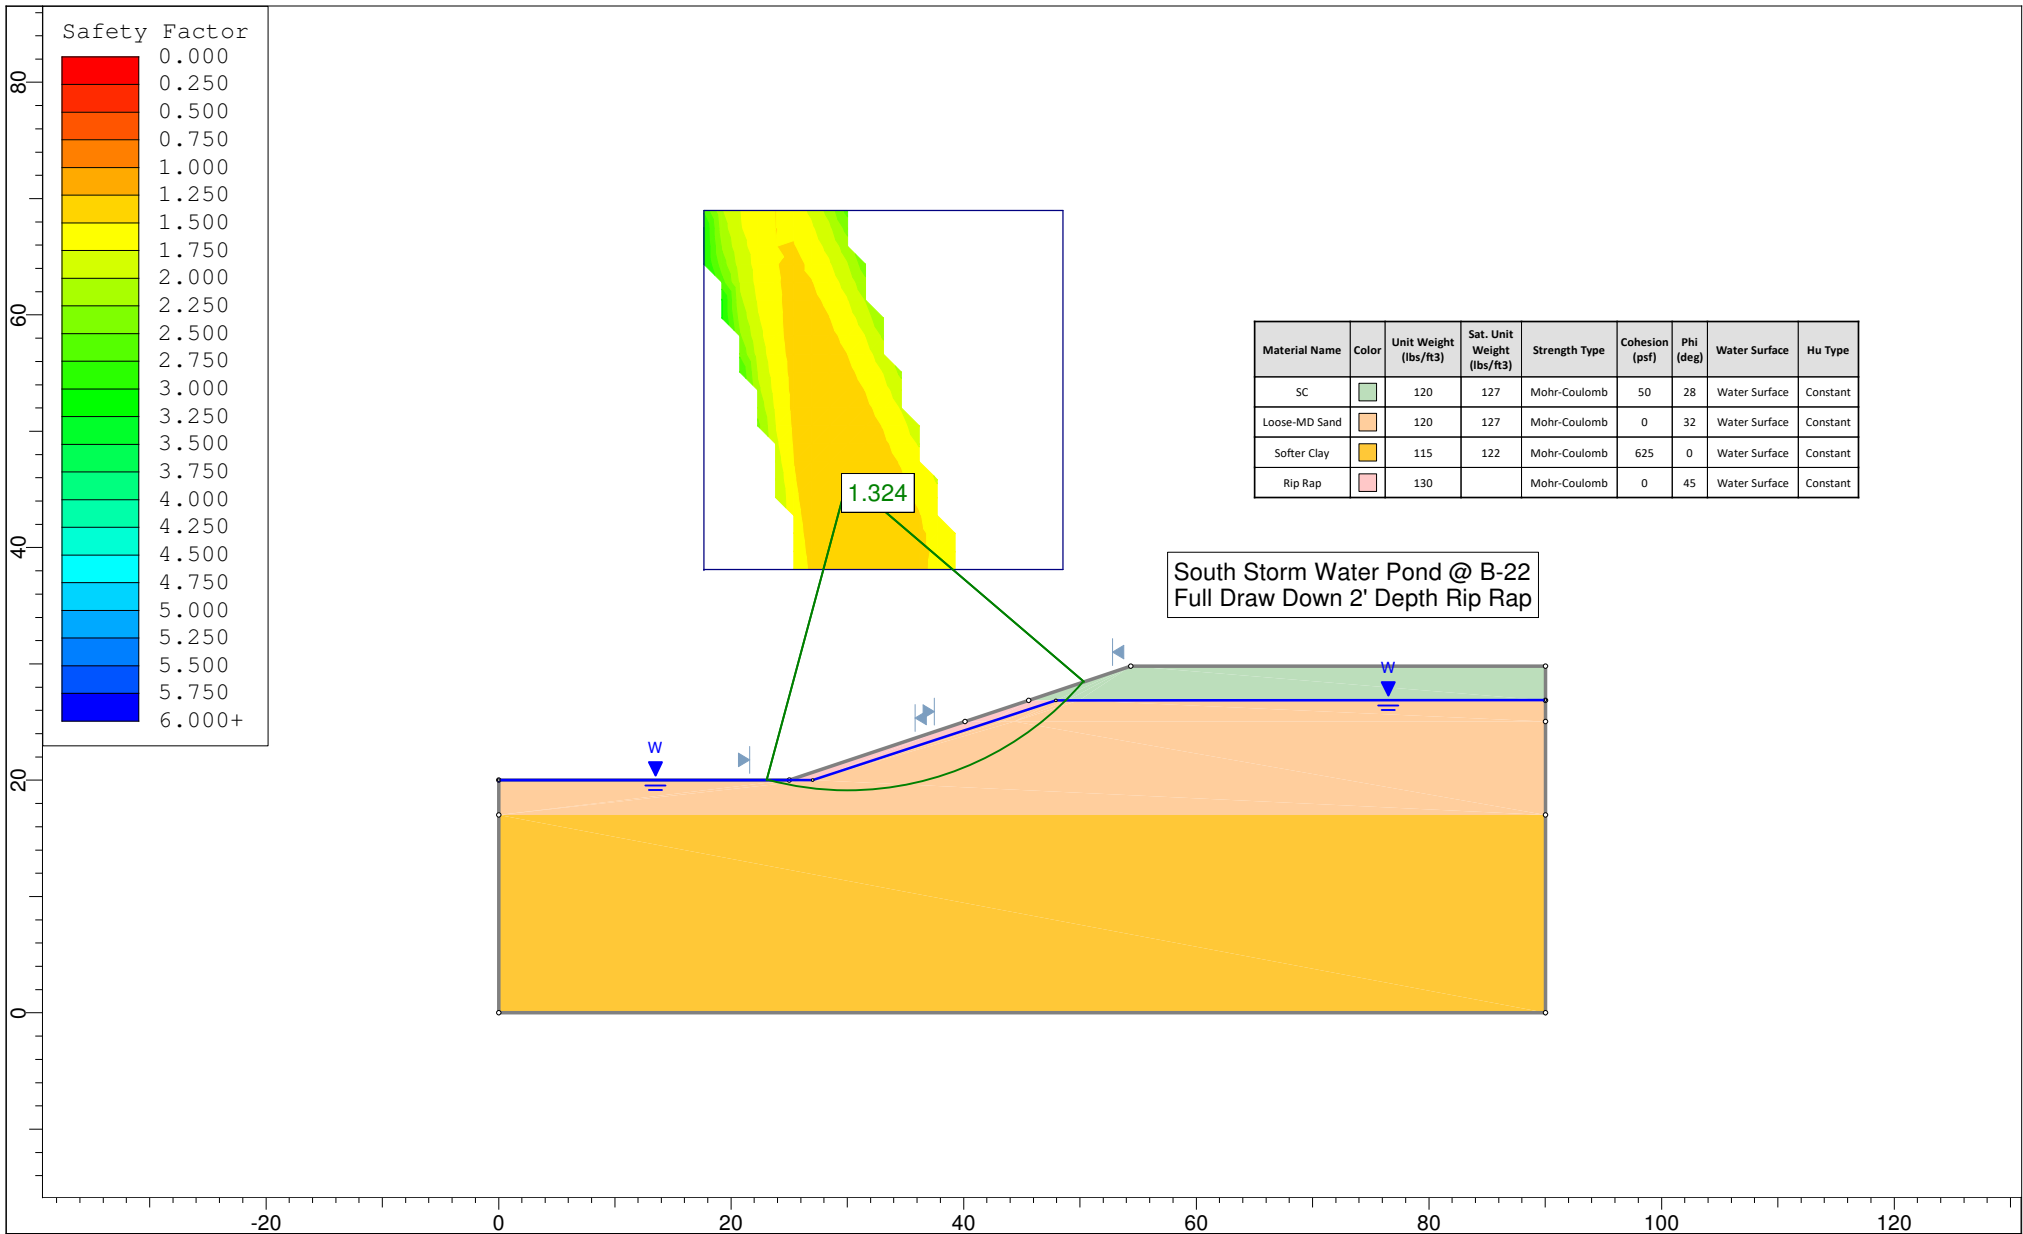
APPENDIX C
SLOPE STABILITY ANALYSES

The deepest cut slopes are located on the south storm water pond. Our analysis of a 10 foot cut slope at the approximate B-22 boring profile indicates a safety factor in excess of 1.5 for a deep seated slope failure which is acceptable. The safety factor against a shallow slide with submerged clean sands is below 1.0 for a seepage condition. This illustrates the need to dewater, and the need to armor submerged slopes with exposed granular soils subject to shallow seepage instability. A typical armoring detail includes a geotextile fabric and rip-rap below the water line for stability, and to reduce long-term maintenance. A 2 foot thickness of rip-rap armor will increase the shallow safety factor to about 1.3 to 1.5+. If full draw down is not expected, or if it will rarely occur, a safety factor of 1.3 is acceptable. If full draw down will occur regularly, additional provisions or possibly more maintenance will be needed. Safety factors for a number of conditions are summarized in the table below:

Draw Down	Shallow Safety Factor	Rip-Rap Thickness (ft)
Full	<1.0	NA
Half	<1.0	NA
Full	1.32	2
Half	1.5+	2

It is noted that the above safety factors are for submerged granular soils, and that materials with increased fines are generally less subject to this type of instability. As such, although consideration could be given to armoring all submerged cuts, it will be more feasible to target only those areas where granular soils with little to no fines are exposed. A geotechnical consultant should be engaged to assist the contractor with identifying such areas. With this approach, it should be understood that increased long-term maintenance is likely, but this approach will still be cheaper than armoring all submerged slopes.
